TECHNOLOGIC PAPERS
OF THE
BUREAU OF STANDARDS

No. 54

SPECIAL STUDIES IN ELECTROLYSIS MITIGATION

III. A REPORT ON CONDITIONS IN SPRINGFIELD, OHIO, WITH
INSULATED FEEDER SYSTEM INSTALLED

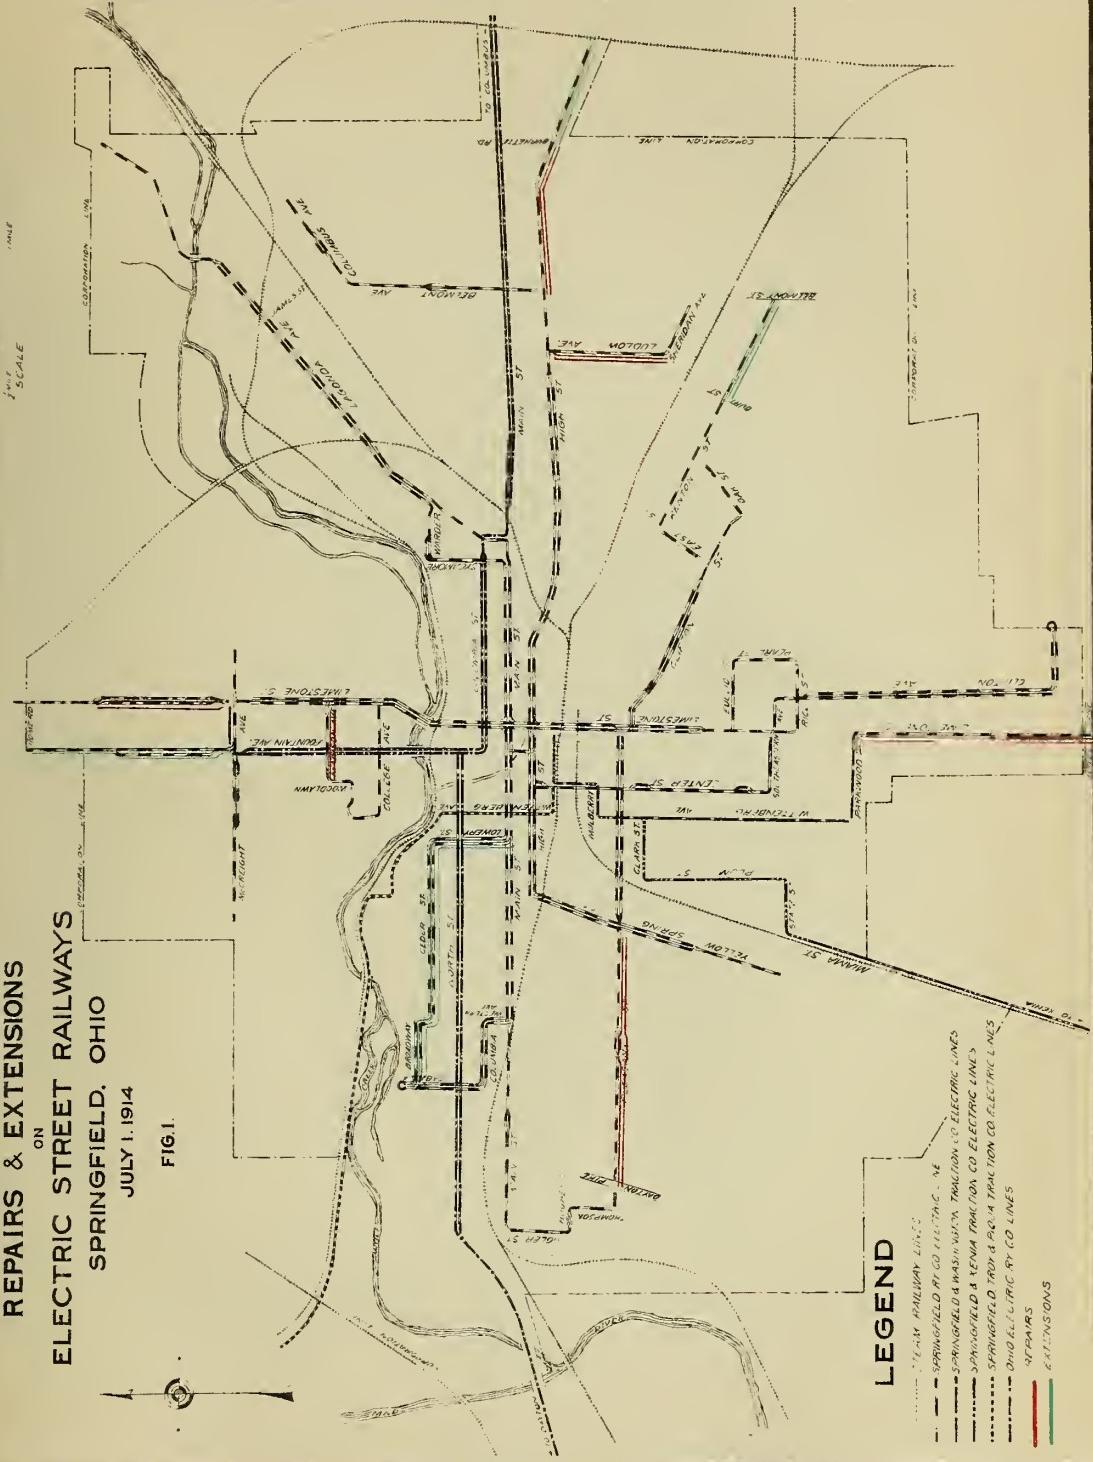
FIG. 1.

Road have been repaired. Work on these two sections was in progress during this survey, and the discussion of the data will have to include consideration of the effect of these sections. Track repair work is so necessary that it seems undesirable to delay or interrupt it on account of a survey, and some track work will be in progress on a system of this size at all times. To get consistent results there should be a minimum number of disconnected tracks. In addition to the above, new work and repairs were planned or in progress at the following points: East High Street from Burnette Road to the Detroit, Toledo & Ironton tracks; West Pleasant Street from Yellow Springs Street to Dayton Road; on Cedar Street and Broadway to Isabella Street; Yellow Springs Street from State Street south; and on North Fountain Avenue from McCreight Avenue to Home Road. These sections are shown by colors on the accompanying map (Fig. 1, opposite p. 10).

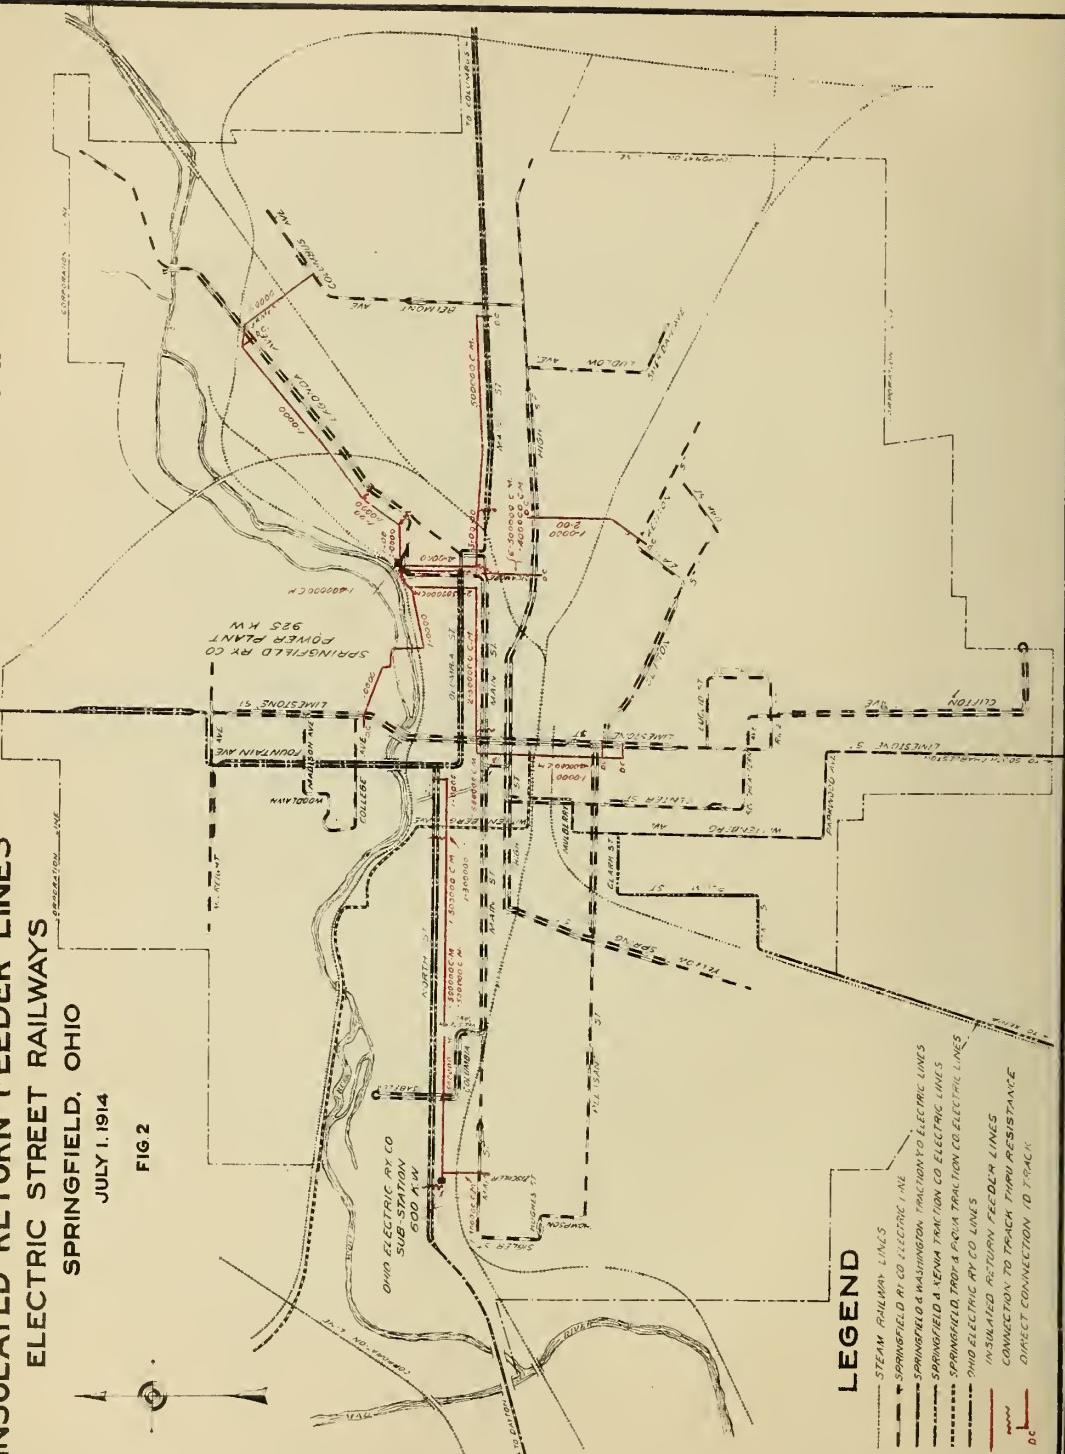
FIG. 2

The insulated return feeder systems are shown on the map in Fig. 2, which shows the location of the feeders, their size and length, and the location and kind of rail connections. It will be noted from the map and table that two stations are equipped with feeders, the Springfield Railway Co. having the more extensive system and the Ohio Electric Railway Co. substation having lines in two directions. The power stations of the three other interurbans are situated well outside the city limits and their loads are too light to require insulated feeders. The map (Fig. 2, opposite p. 11) and Table 1 show certain feeders not specifically recommended by Technologic Paper No. 27, as follows: The No. 0000 feeder to College Avenue and Limestone Street, erected before the first survey, has been left in place as has that on East Street from Kenton to High Streets. A 500 000 circular mil cable was erected on Main Street from Lincoln to Belmont Avenues and connected to the Springfield Railway return feeders to take care of the current until this track was relaid and rebonded, it being planned to repave this street soon. The feeders on North Street, extending from the substation to Fountain Avenue, were originally installed to drain the underground pipes of current. These have been cut over to the rails as shown. The feeders are chiefly copper-strand cable with weatherproof insulation strung on the same poles with the positive feeders.

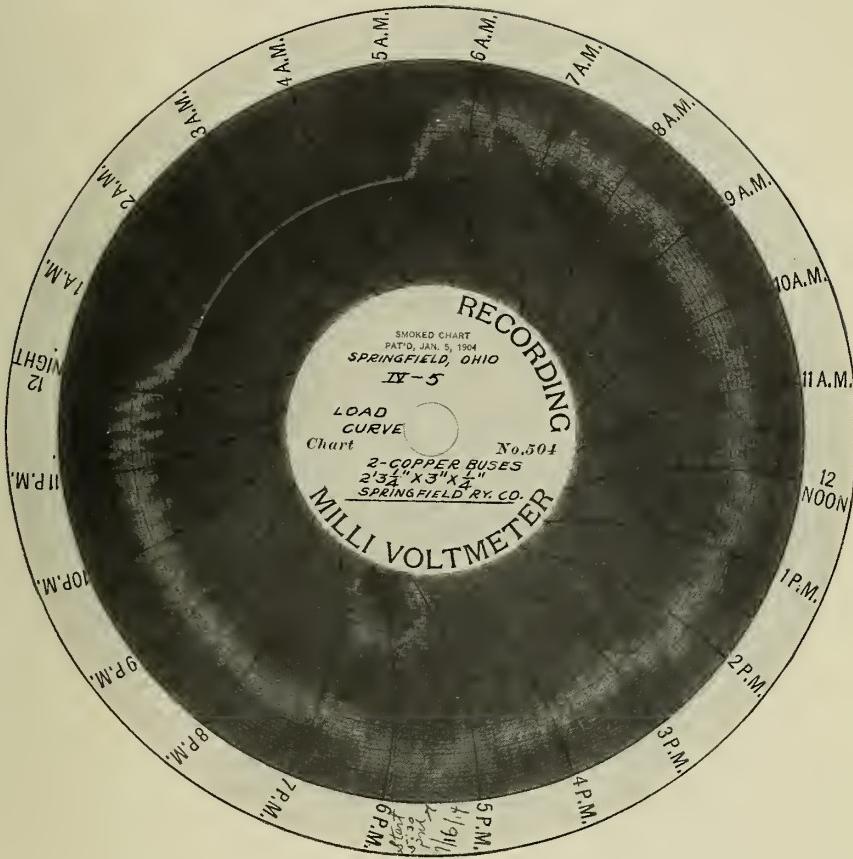
FIG. 3

The readings were taken chiefly with five Bristol smoked chart millivolt meters each having 5-0-5 millivolt scale, a resistance of about 2.5 ohms, corresponding to 500 ohms per volt, multiplying ranges of 5-20-500-2000-10 000- and 30 000 and a period of about 30 seconds. Typical 24-hour and 1-hour charts are reproduced in Figs. 3 and 4. The first chart (Fig. 3) is a 24-hour record of the millivolt drop on a length of copper bus carrying the total load of

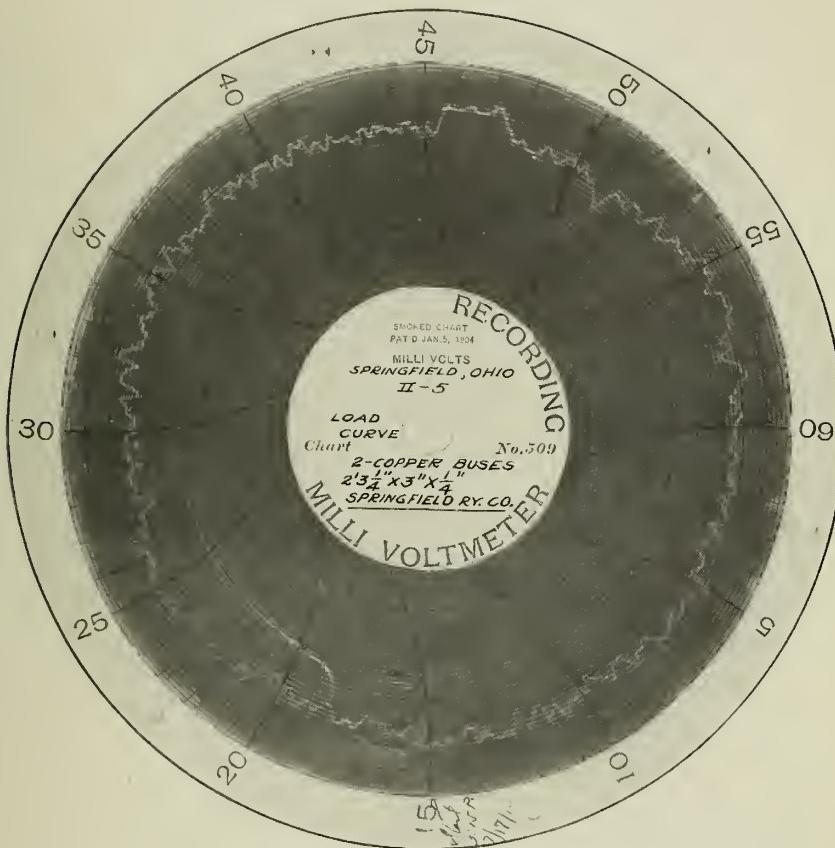
FIG. 4

Springfield Railway Co. The width of the band on the record shows the difficulty in getting an accurate average of each hour or quarter hour. In order to assist in averaging the 24-hour charts several 1-hour charts were taken of the same potential during the same day, one of which is reproduced (Fig. 4, opposite p. 22). The fine sharp line of this record may be very closely followed with a planimeter and an accurate average obtained. This makes clear one reason why chiefly 1-hour records were obtained, another reason also is the larger number of 1-hour charts that can be made in a given time. The values in millivolts are obtained from the 24-hour charts by inspection while the 1-hour charts are integrated with a polar planimeter by means of which results checking to within 1 or 2 per cent on the higher readings may be obtained, which is better than is possible by inspection, and the integrating process is also much faster. Indicating instruments were used where momentary simultaneous values were desired or where the sensitivity of the recorders was not sufficient. For example, in taking the current readings by the method of measuring a voltage drop on a solid length of main the voltages were universally so low as to require a portable galvanometer to give a readable deflection.

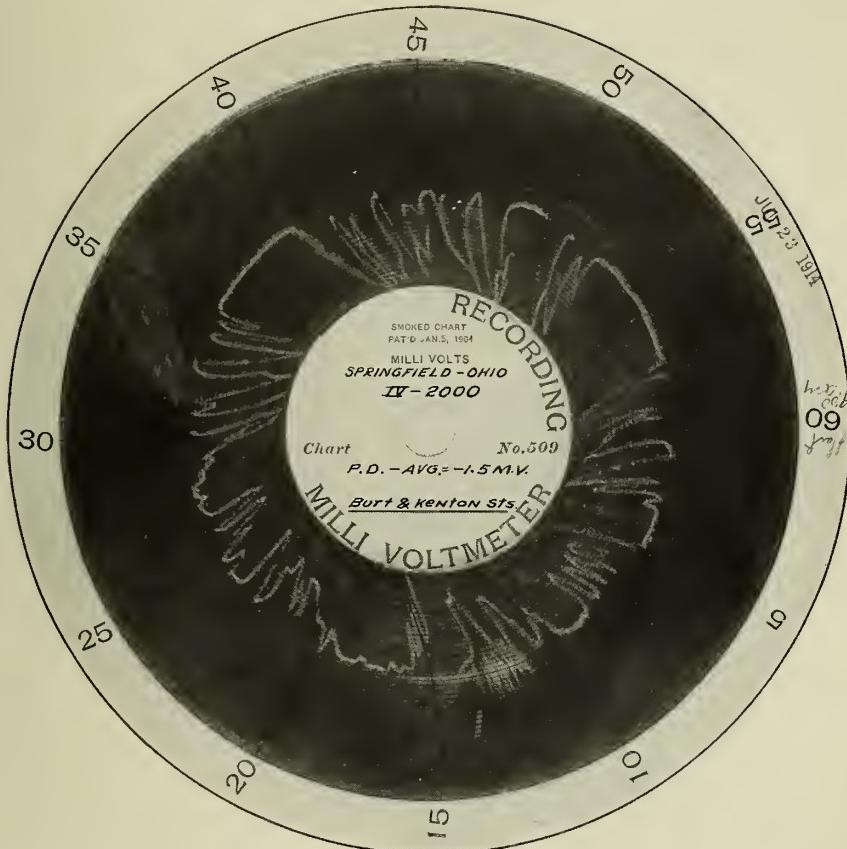
FIG. 8

The effect of track bonding is well shown on the two charts of potential difference, Figs. 8 and 9. As seen by the first chart (Fig. 8, opposite p. 30), the reading was taken at Burt and Kenton Streets on July 23, 1914, at 9 a. m., and the range was 2000 or multiplied by the primary range of the instrument equals 10 volts. The instrument swung off scale several times and the average for the hour is over 3 volts, the pipe being negative to the rail. The track was evidently in bad condition, and the track on this line, including Kenton, Oak, and Clifton Streets, was tested and repaired, and when the chart (Fig. 9, opposite p. 30), dated August 6, 1914, at 11.32 a. m., was taken, using the same instrument range, it will be noted that none of the swings reach 3 volts and the average is less than 1 volt. Reduced to all-day average the preceding value is -2.4 volts and the succeeding value -0.72 volts. This emphasizes the importance of track maintenance. Similar conditions still exist at several points in Springfield where larger negative values may be observed and these of course increase the positive values in the territory about the station supplying the line in question.

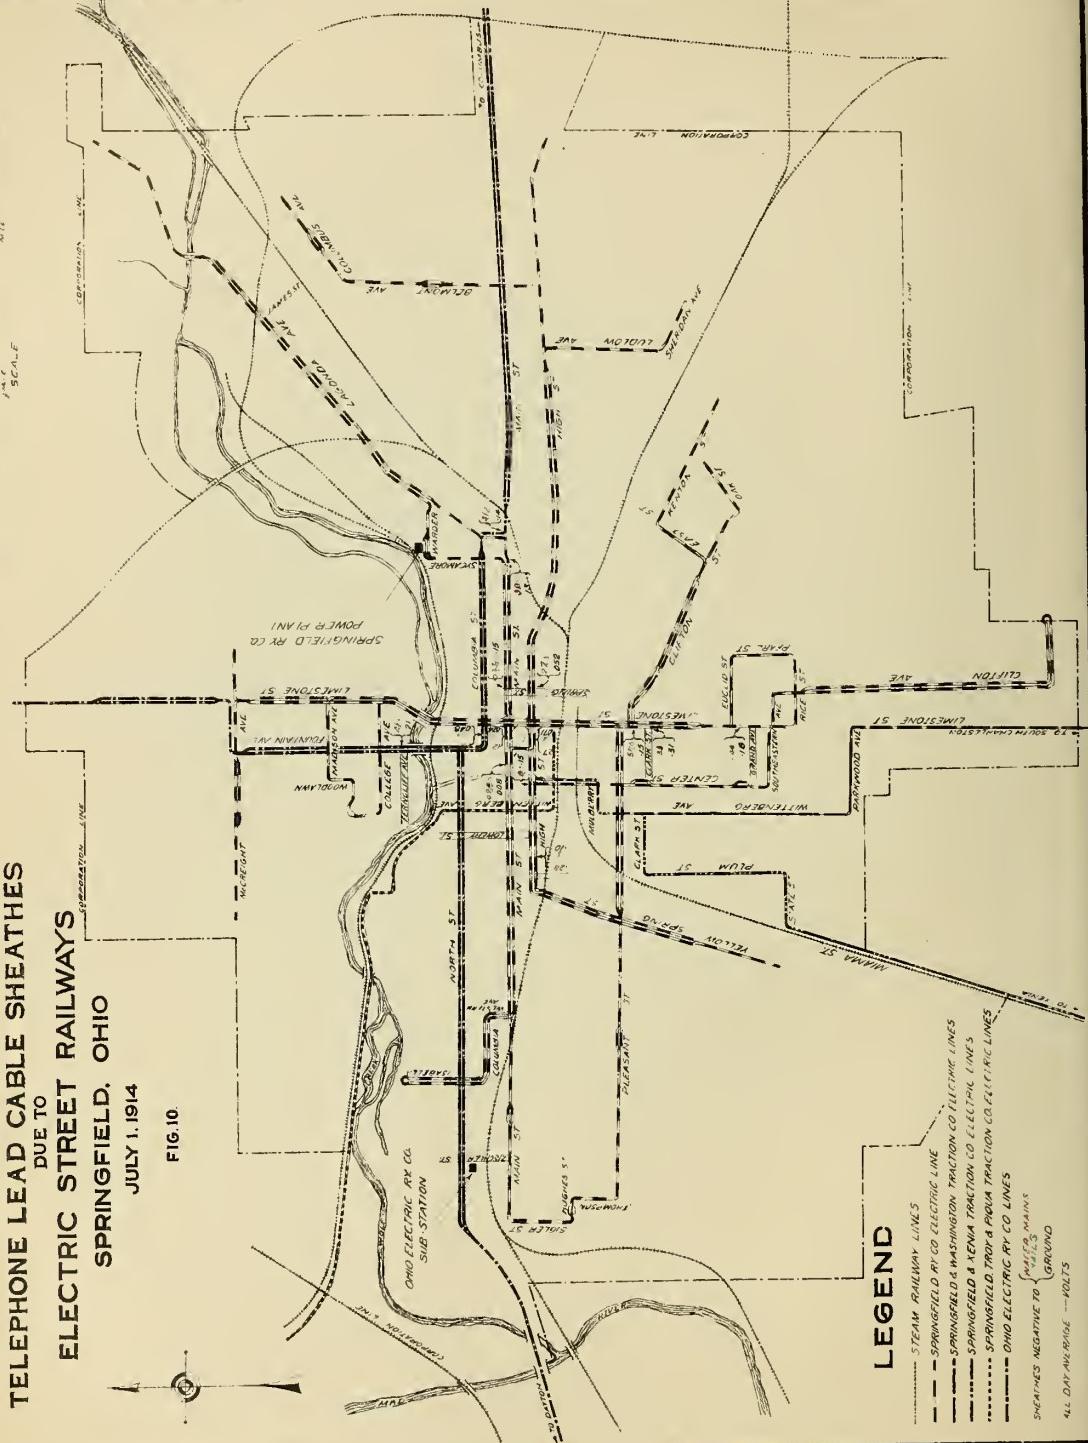
FIG. 10.

POTENTIAL DIFFERENCES
OF
TELEPHONE LEAD CABLE SHEATHES
DUE TO
ELECTRIC STREET RAILWAYS
SPRINGFIELD, OHIO
JULY 1, 1914

(c) *Lead Sheaths to Other Structures.*—Potential difference readings were taken on the Central Union Telephone Co.'s lead sheaths at 14 different manholes, distributed over a system having about 50 such locations. One-half hour readings, using an indicating voltmeter between the sheath and water mains and recorders between sheath and rail and sheath and ground are given in Table 9 and Fig. 10 (opposite p. 31) and show the sheath to be negative to these structures at all points, the values varying from 1.4 volts to almost zero for the maximum hour. The lower values were noted between sheath and ground, where the magnitude is quite an indefinite quantity due to earth gradients, chemical potentials, and high-resistance contacts. An additional column is added showing the portion of the time that the sheath is positive. At Main and Sycamore Streets the sheath is positive to rails for 16 out of 30 minutes with an average of 0.10 volt, but at the same point it was not positive to pipe or ground for any portion of the period so that it can hardly be considered a dangerous condition. The all-day average potential to rail is -0.32 volt, to water mains -0.28, and to ground -0.12, all values low enough to create no serious hazard to other structures, as is the case where sheaths are overdrained, but safe also from the standpoint of the cables. This has been accomplished with three drainage points taking somewhat more current from the cables than formerly, as will be shown later, but giving much better potential conditions with no extremes.

These potential differences are reproduced on map (Fig. 10, opposite p. 31), which will assist in giving an idea of the extent of the underground cable system as the readings cover the area quite completely.

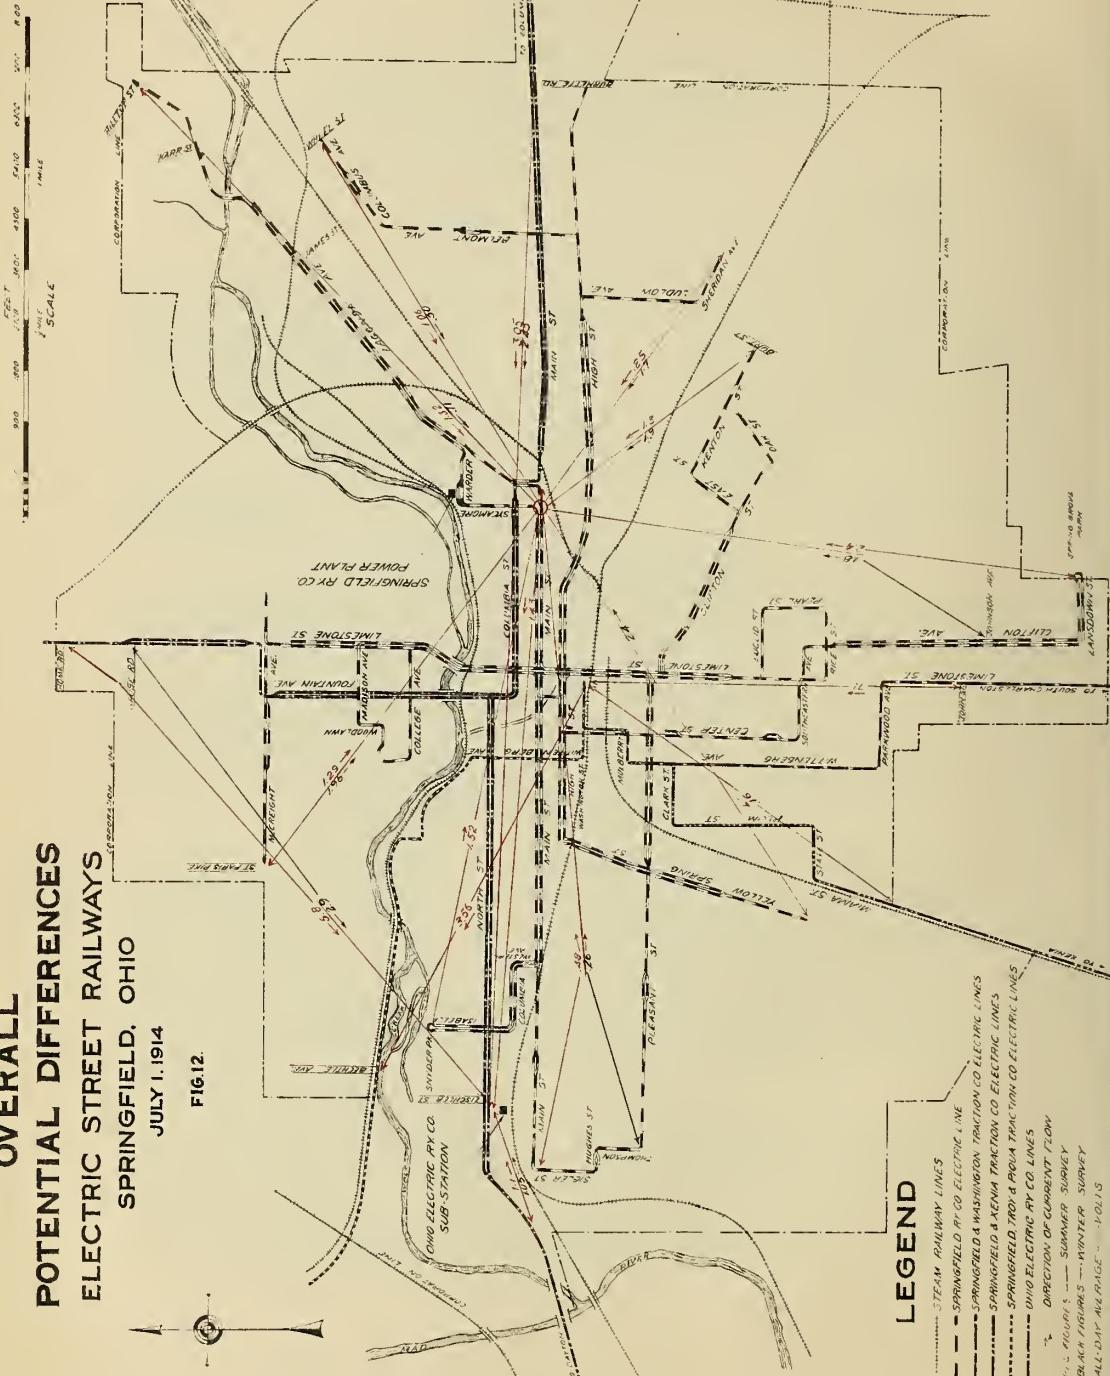
FIG. 12.

point of lowest potential, as explained below. The outlying points are enumerated in Table 6, giving the pressure wire resistance. The over-all potentials are shown in Tables 13 and 14 and shown on the map in Fig. 12 (opposite p. 41). The Ohio Electric Co. has four pressure wires extending from the waiting station at Columbia Street and Fountain Avenue to the tracks at North and Zischler Streets and to the city limits on the east, north, and west. The reference point of other interurban lines is at their waiting station at Washington Street and Fountain Avenue, and the other wires extend from this station to the track intersection with the corporation line.

OVERALL POTENTIAL DIFFERENCES ELECTRIC STREET RAILWAYS SPRINGFIELD, OHIO
